## Tasman Bridge improvements

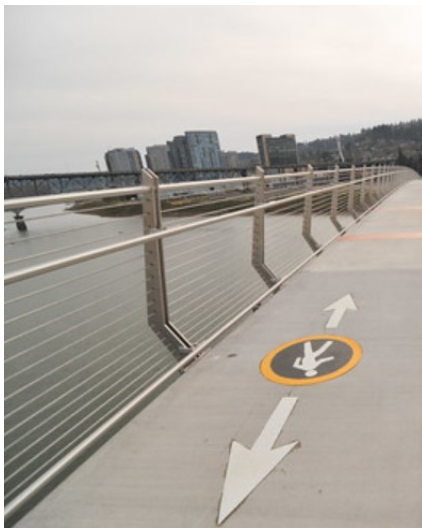
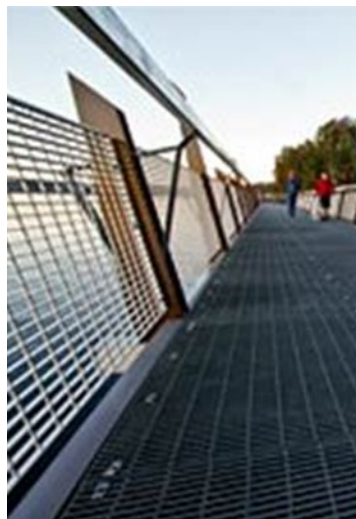
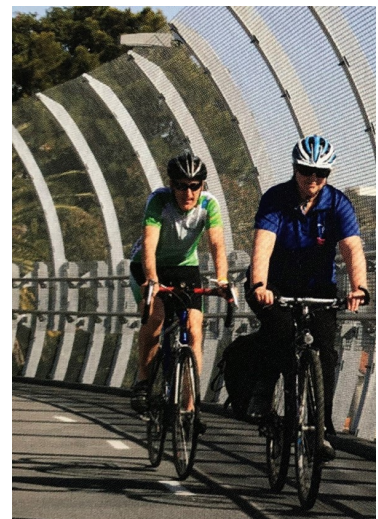
- As part of the replacement and increase in height of the external railing, incorporate angled struts to create increased clearance for pedals and handlebars (see photo examples).

- Include a rubbing strip on the railings at handlebar height, such as a flat, perforated aluminium plate, so the handlebars deflect rather than get caught in the railings. This would not be required on the external rail if the struts are angled to provide increased clearance for pedals and handlebars.

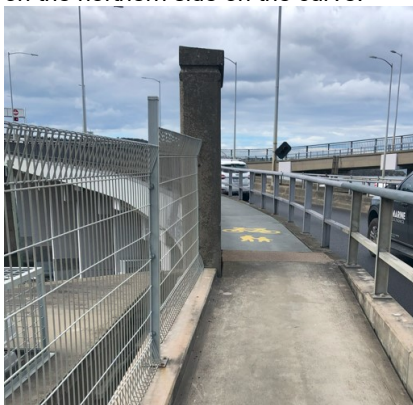
Site 1 - Widen pathway on western end of bridge on the northern side on the curve.

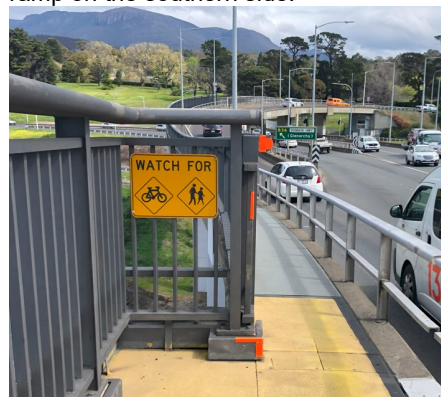
Site 2 - Widen pathway from passing bay to the circular ramp on the southern side.

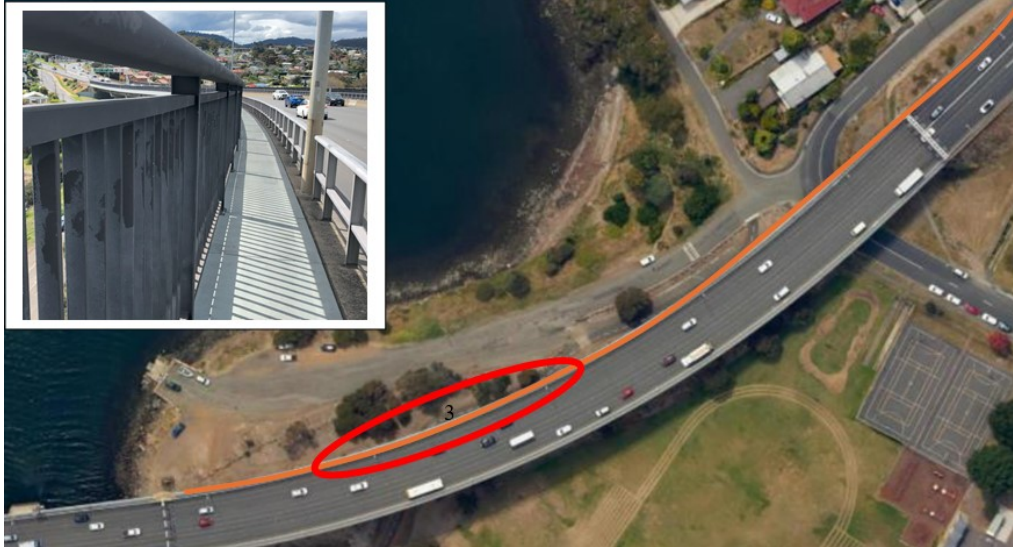
### Site 3 – Widen pathway from overhead land use management system gantry to Topham St

- There are three locations where sight distance is limited due to the view lines being blocked by the outside railing on a curve, which can result in head-on collisions or near misses where hard braking results in the rider going over the handlebars. These curves are located at the ends of bridge that are over land rather than water so there may be capacity to widen the pathways at these problem spots to 1.8m to allow people to avoid a collision. Careful consideration should be given to the handrails to ensure they don't block sight lines.

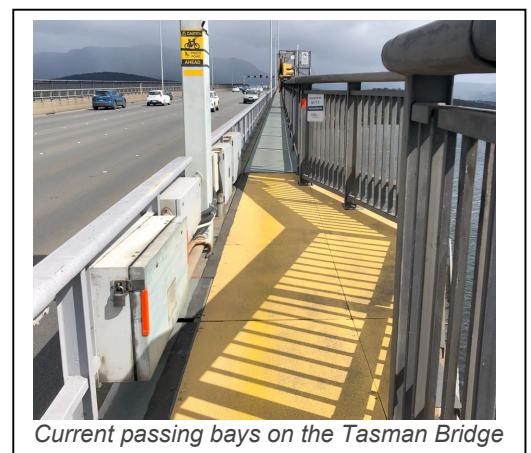
Locating passing bays at the apex as well as opposite services (see photo, right) would be an improvement.

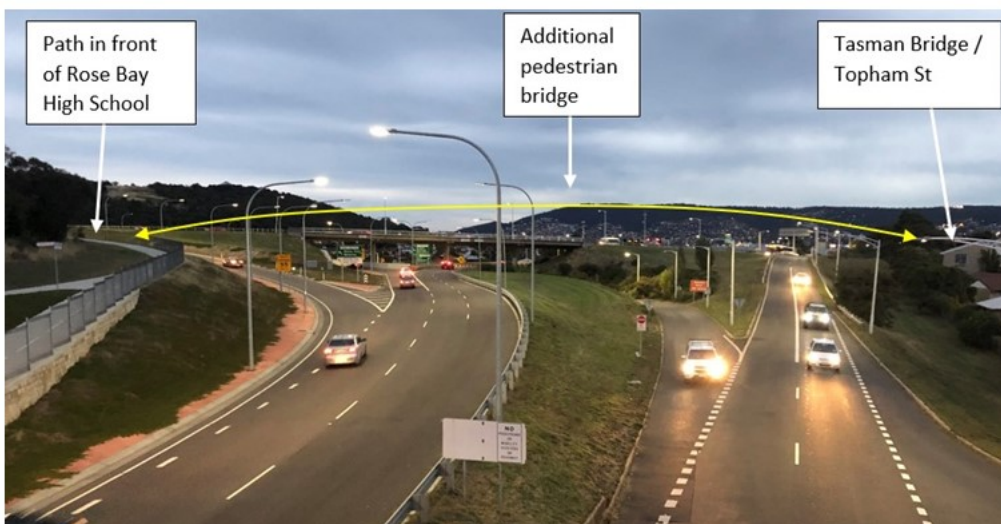
The upstream (northern) side of the bridge provides the only off-road connection to Rosny Park but the only way to cross the East Derwent Hwy is to use the Yolla Street overpass. This 56 year old structure has 36 steps on it and is a 500m detour off the desire line.

*View from Yolla St overpass on the East Derwent Hwy looking towards the Tasman Hwy interchange*

The northern side of the Tasman Highway at Rose Bay will become the main arterial cycling route once a suitable crossing is provided over the East Derwent Hwy. We would like to see this bridge constructed as part of the Tasman Bridge project now that the Tasman Bridge widening has been significantly scaled back, even if additional funding needs to be secured. Federal Active Transport grants are available.

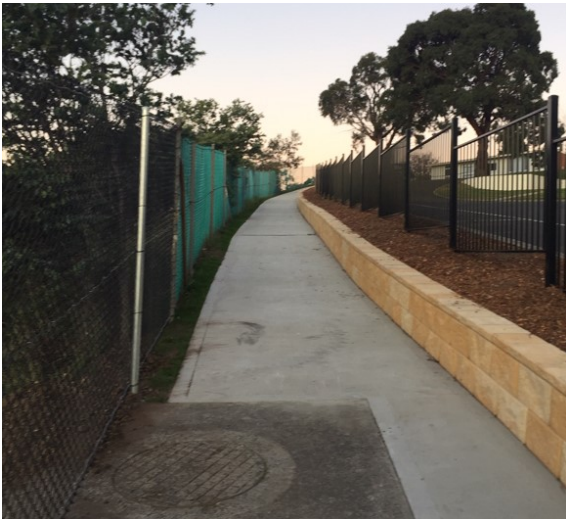
1.8m wide path alongside the Tasman Hwy connecting to Montagu Bay Road.

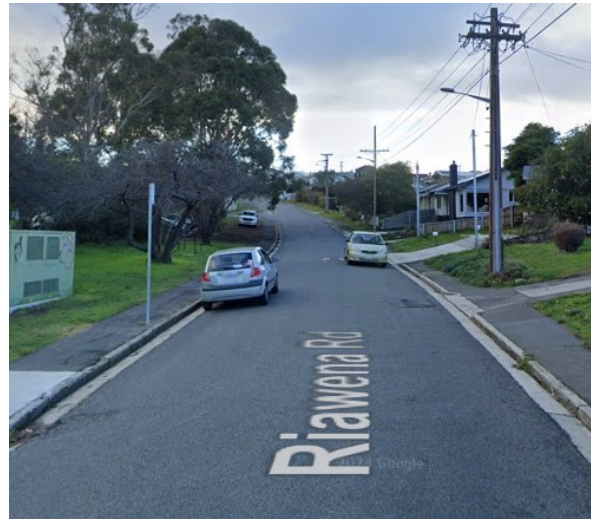
Riawana Road – a narrow road with awkward camber and high degree of on-street car parking. Also a bus route.

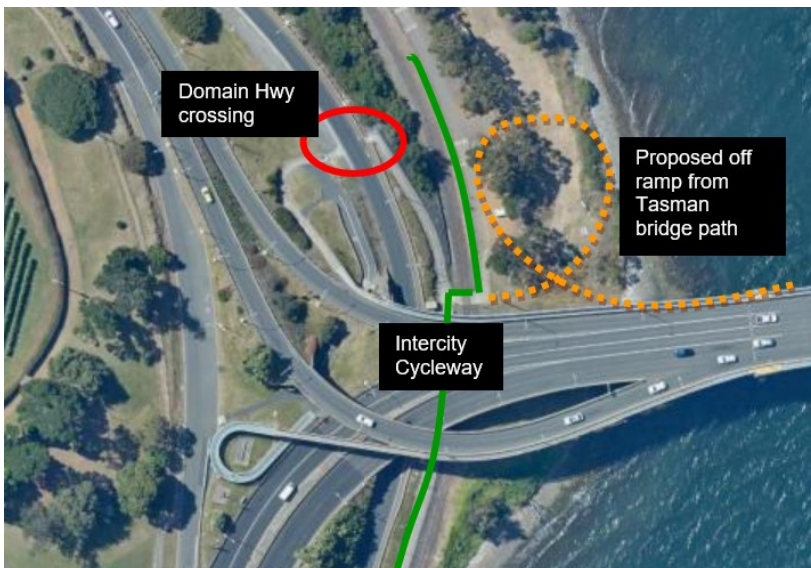
The crossing of the Domain Highway slip lane is of concern to some riders (shown as red circle). An off ramp was shown in the original bridge design on the southern side to connect to the Intercity Cycleway in the Hobart direction. It is preferable for the ramp to be on the northern side which would eliminate the road crossing. Riders on the southern side of the bridge can avoid the road crossing if they prefer by riding a short way along the northern path to access the ramp.

This is considered a lower priority than other proposed improvements as the crossing is only a single lane with traffic coming from one direction. A reduction in speed limit on the Domain Hwy, which has multiple uncontrolled intersections, to 60km p/h would be an acceptable solution.
