## Tasman Bridge improvements

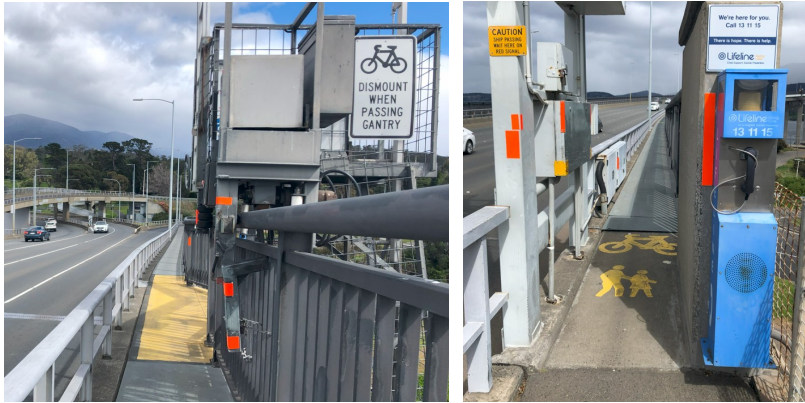
## 2. Fixed objects protruding onto the path

2. **Fixed objects protruding onto the path** such as gantrys, concrete abutments at entry points and service infrastructure that can cause injury when collided with;

- The project managers are investigating options for relocating gantrys and services off the path. Concrete abutments at the entry points also need to be addressed. This is essential to improve the safety of the pathways.

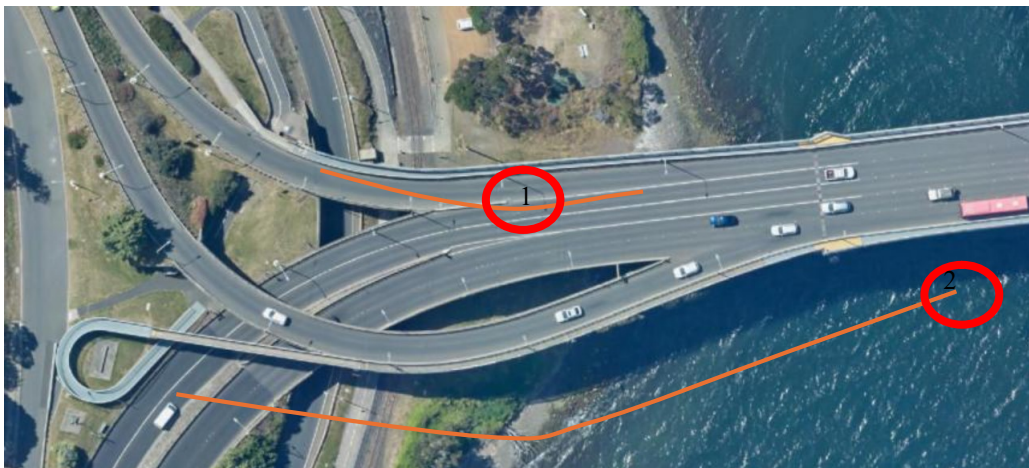
### Western shore

- There are three locations where sight distance is limited due to the view lines being blocked by the outside railing on a curve, which can result in head-on collisions or near misses where hard braking results in the rider going over the handlebars. These curves are located at the ends of bridge that are over land rather than water so there may be capacity to widen the pathways at these problem spots to 1.8m to allow people to avoid a collision. Careful consideration should be given to the handrails to ensure they don't block sight lines.

Site 1 - Widen pathway on western end of bridge on the northern side on the curve.

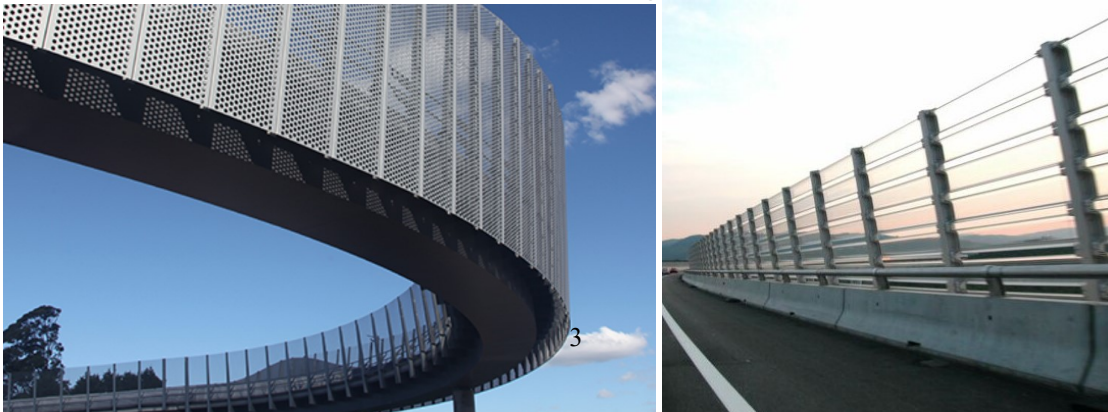
#### 4. **Buffering from the wind**

4. **Buffering from the wind** makes riding in a straight line difficult and increases the likelihood of a collision with railings or gantrys;
5. **Inability to pass** when wide bicycles (such as cargo bikes or touring cyclists with panniers) or mobility scooters users meet, requiring one to reverse back.

It is desirable to have some form of wind protection such as solid or perforated screens to reduce wind buffering on the paths but these would increase wind loading on the bridge structure. We are informed that this is not an option and the new railings will aim to increase porosity.

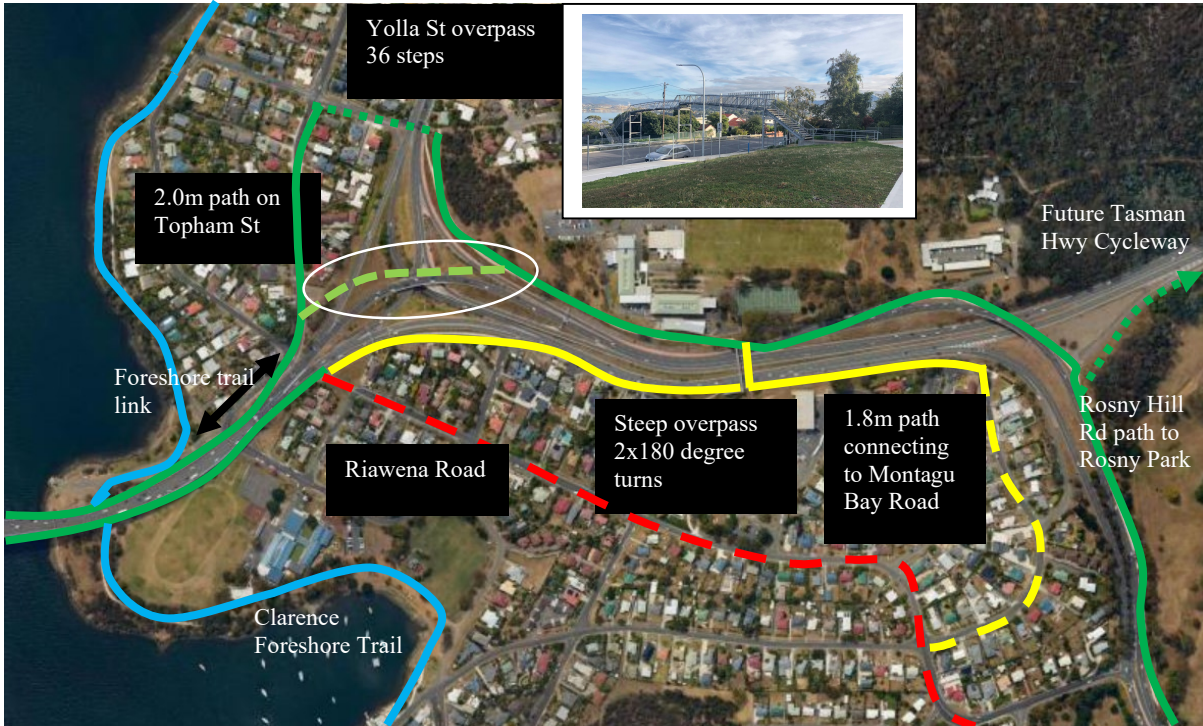
### Improving eastern shore access

The upstream (northern) side of the bridge provides the only off-road connection to Rosny Park but the only way to cross the East Derwent Hwy is to use the Yolla Street overpass. This 56 year old structure has 36 steps on it and is a 500m detour off the desire line.

The northern side of the Tasman Highway at Rose Bay will become the main arterial cycling route once a suitable crossing is provided over the East Derwent Hwy. We would like to see this bridge constructed as part of the Tasman Bridge project now that the Tasman Bridge widening has been significantly scaled back, even if additional funding needs to be secured. Federal Active Transport grants are available.
